**2019 Therrien/ Lanata Eversource Right-of-Way Investigation
New London Turnpike, Glastonbury, CT
Photos by REMA Ecological Services, LLC**

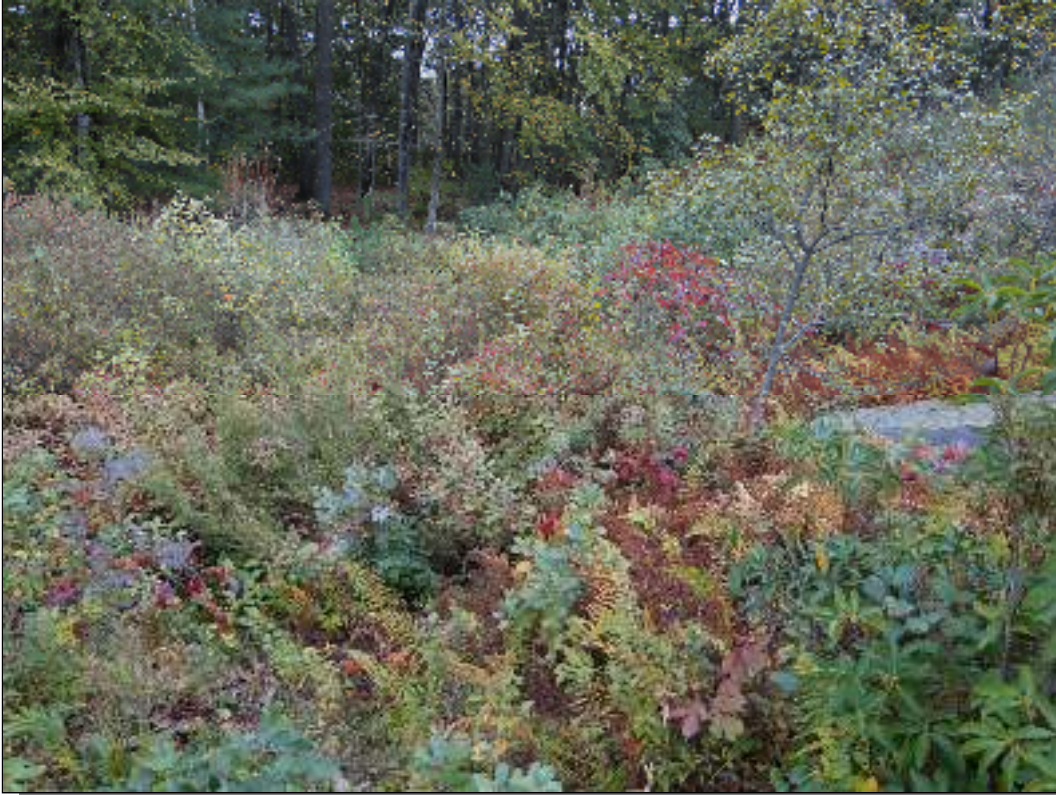
Photo 1: Study area, southwestern ROW segment, on Therrien property; low shrub-meadow cover type on hillside, facing southeasterly.

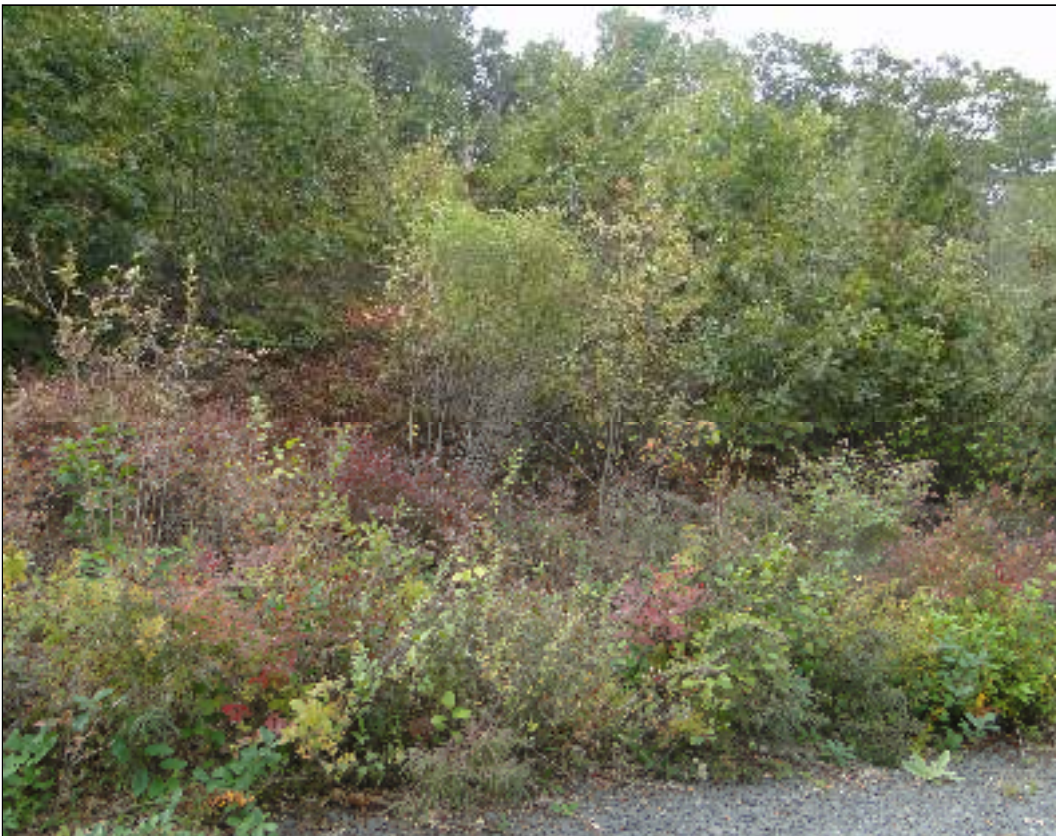
Photo 2: Steep hillside in study area, facing northwesterly, on Lanata property; mix of high shrub and low shrub cover types; huckleberry at center is dark red-brown. 10-7-19.

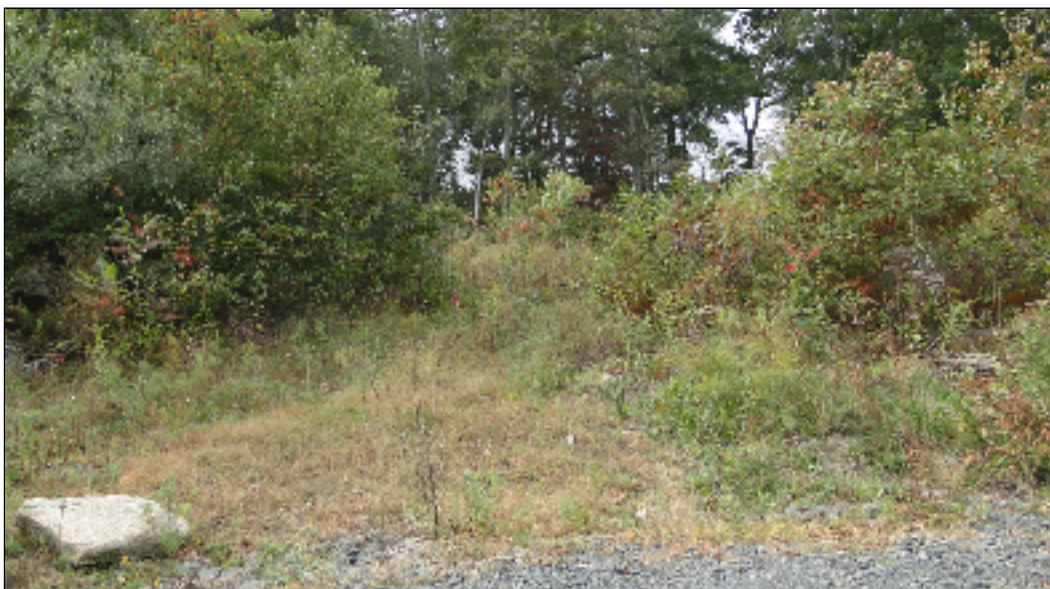
Photo 5: Mosaic of low shrub, meadow & high shrub cover types in Plot 1 in the southwestern ROW segment, on Lanata property, facing northwesterly. 10-7-19.

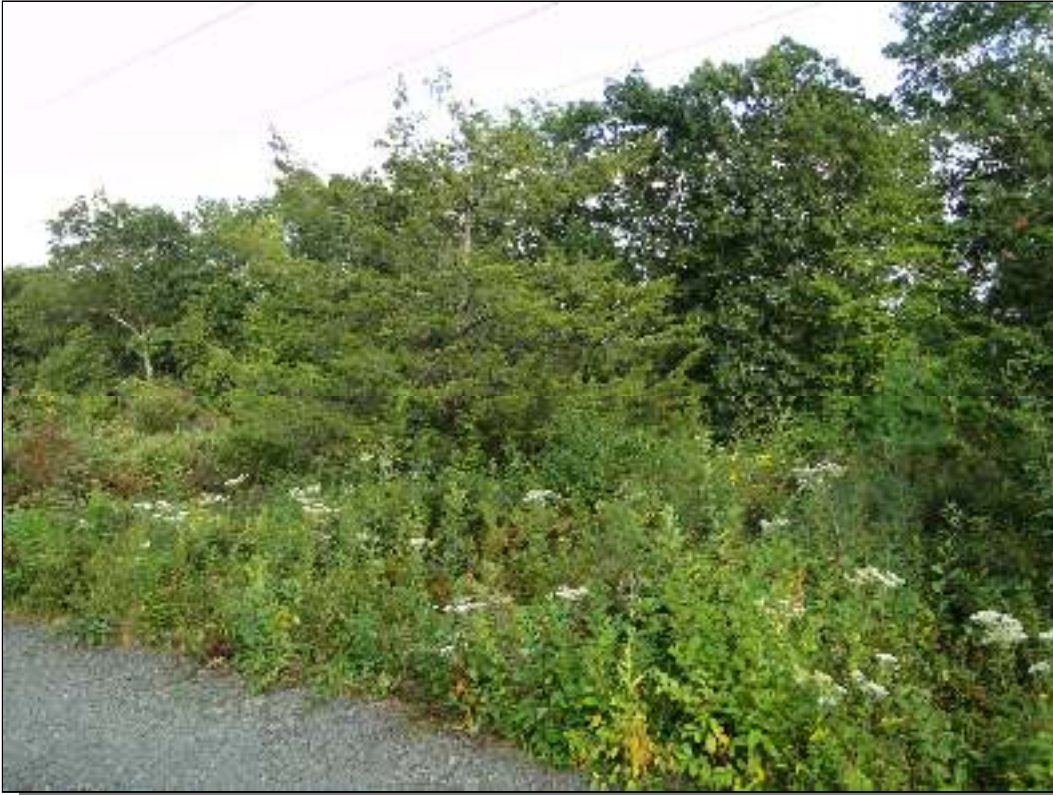
Photo 7: Study area, southwestern ROW segment; low shrub-meadow cover type on hillside, facing easterly. Note topped red cedar and blooming rough boneset 9-10-19.

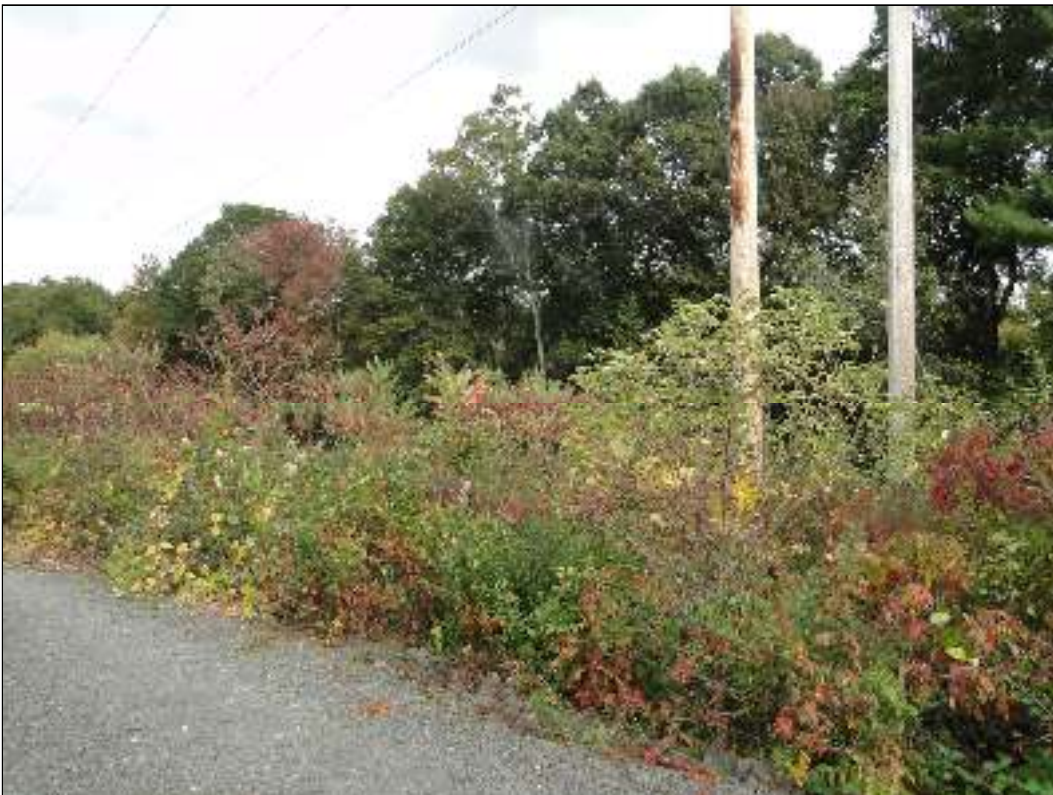
Photo 8: Mid slope shrub thicket, with elderberry, grape, and winged sumac, facing easterly, on Therrien property; low shrub-meadow cover type; 10-7-19.

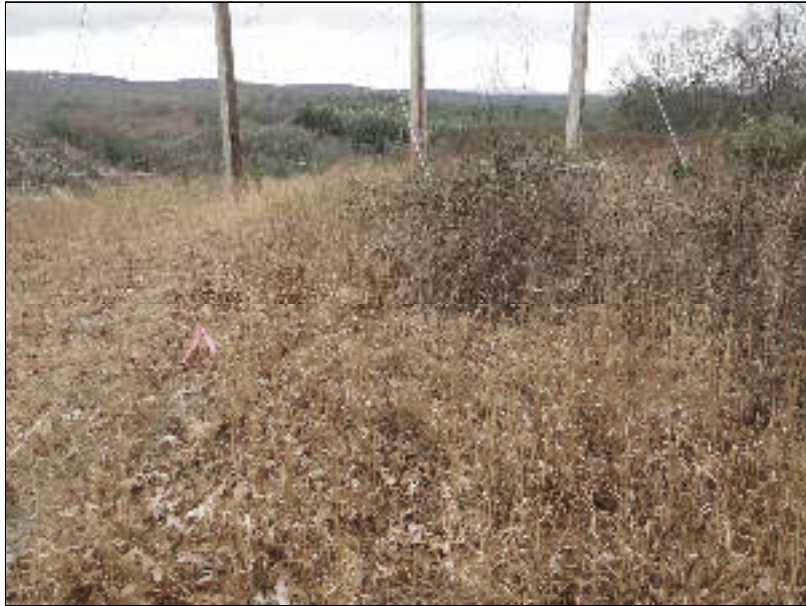
Photo 13: Dense grasses & fine-bladed, rhizomatous Penn sedge dominate the east side of Plot, 3 with very few deciduous tree seedlings.

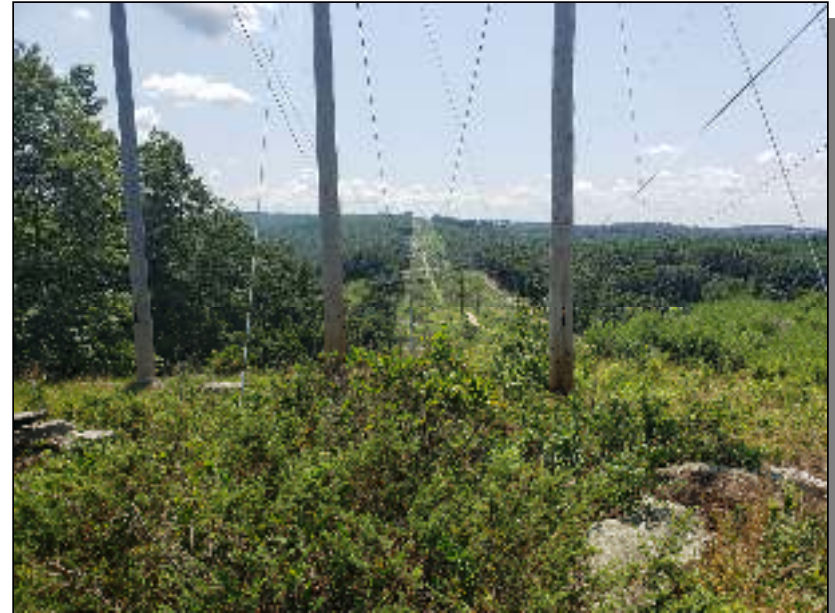
Photo 14: Shrub-dominated section of Plot 3, the control hilltop plot, to the east of bedrock sill, that defines western boundary of plot. 8-10-19.

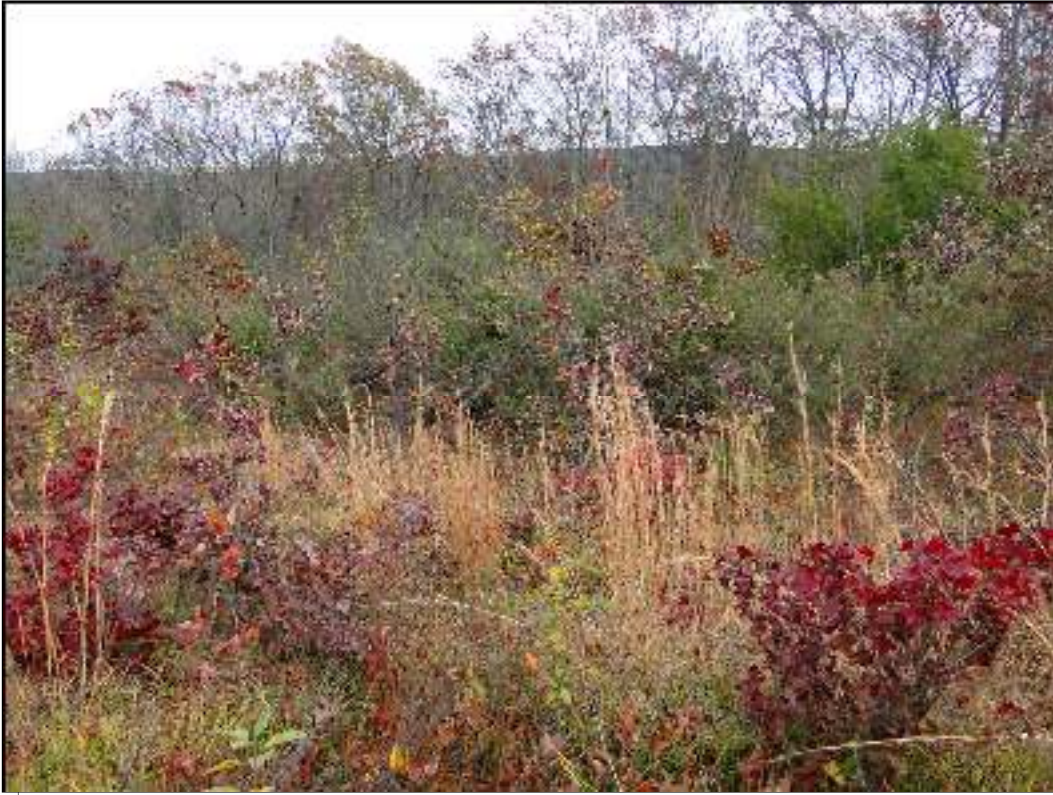
Photo 17: Study area, southwestern ROW segment, low shrub-meadow cover type on hillside, facing southeasterly. Note red cedar and blooming rough boneset 9-10-19.

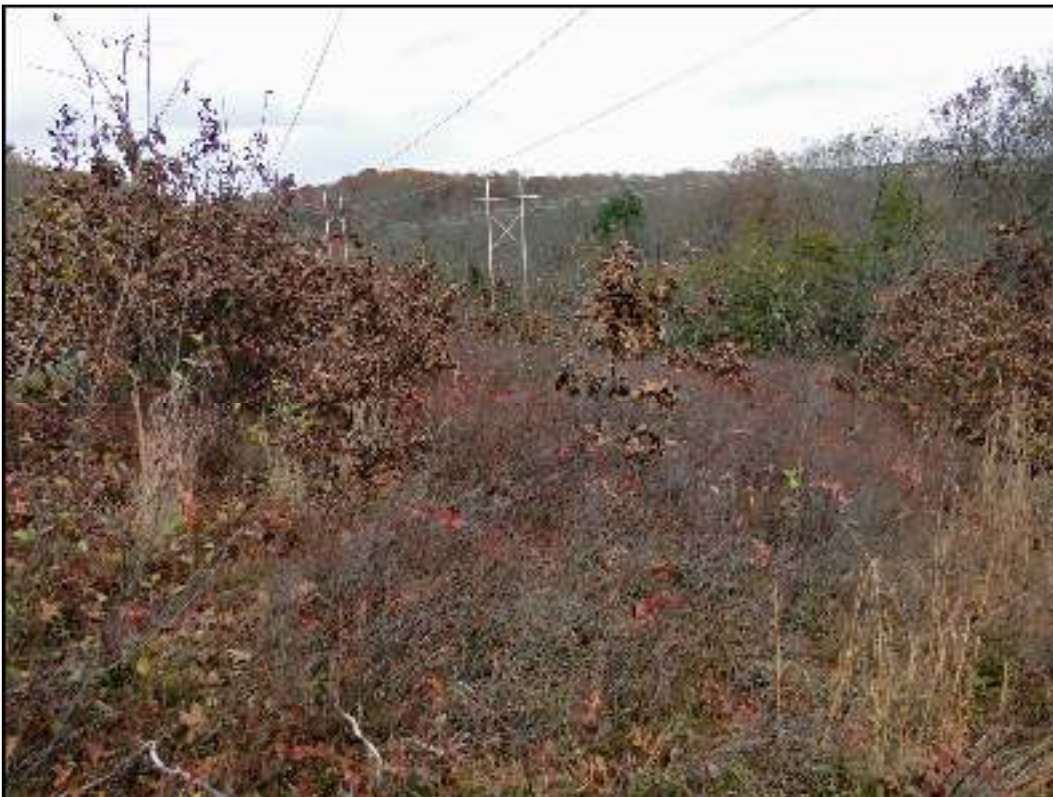
Photo 18: Large hillside areas of low ericaceous shrubs (huckleberry & blueberry); oak saplings are on the perimeter, but not within the patches. Facing northeasterly. 10-7-19.

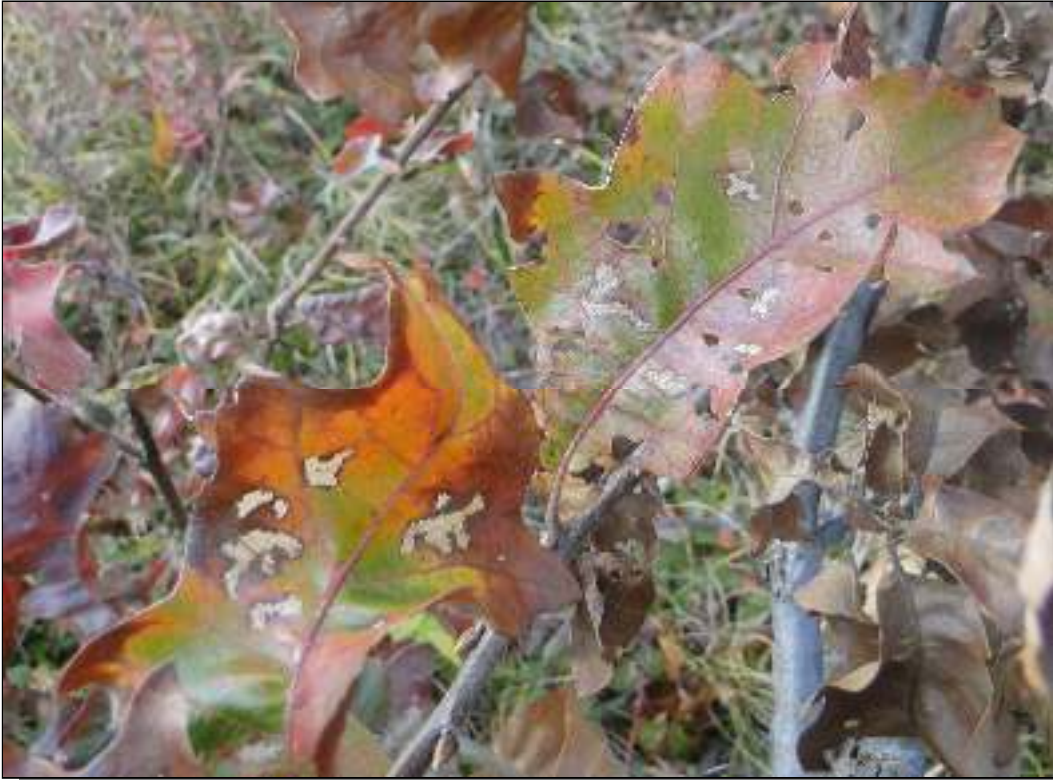
Photo 19: Study area, SW ROW segment, upper hillside, with patches of oak saplings and seedlings. 11-8-19.

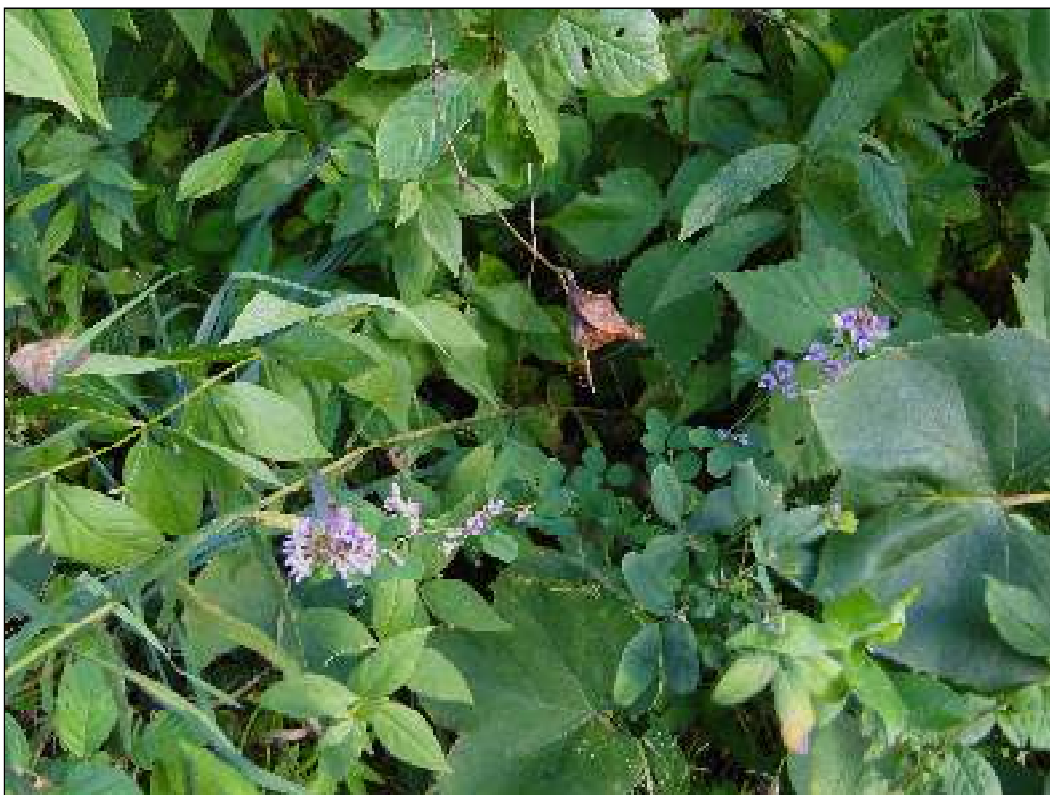
Photo 21: Diverse roadside herb stratum on lower hillside (Plot 1) with whorled loosestrife, violet bush clover & an uncommon tick trefoil, *Desmodium ciliare* (8-16-19).

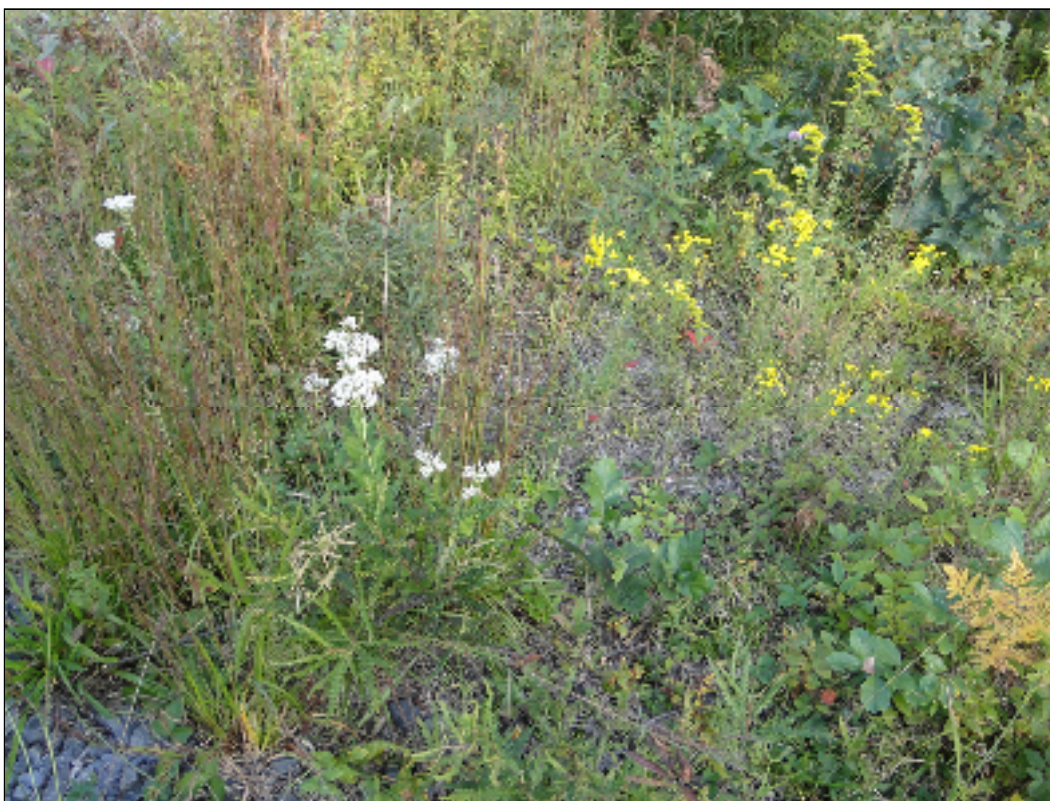
Photo 22: Dry roadside on upper slope with low-growing vascular plants include gray goldenrod, sweet fern, upland boneset, bracken fern, and little blue stem. 9-10-19.

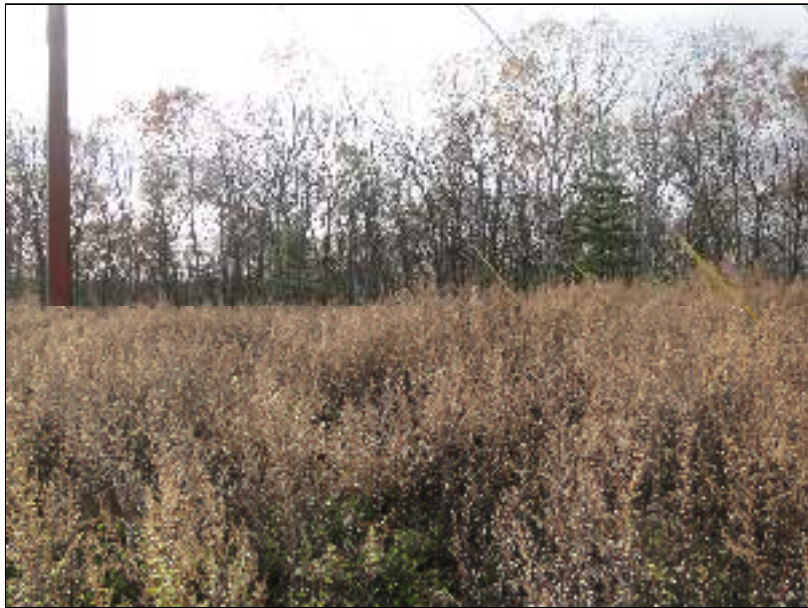
Photo 23: Replacement of wooden poles with steel poles resulted in $\frac{3}{4}$ acre of dense mugwort, *Artemisia vulgaris*, on Work Pad # 1

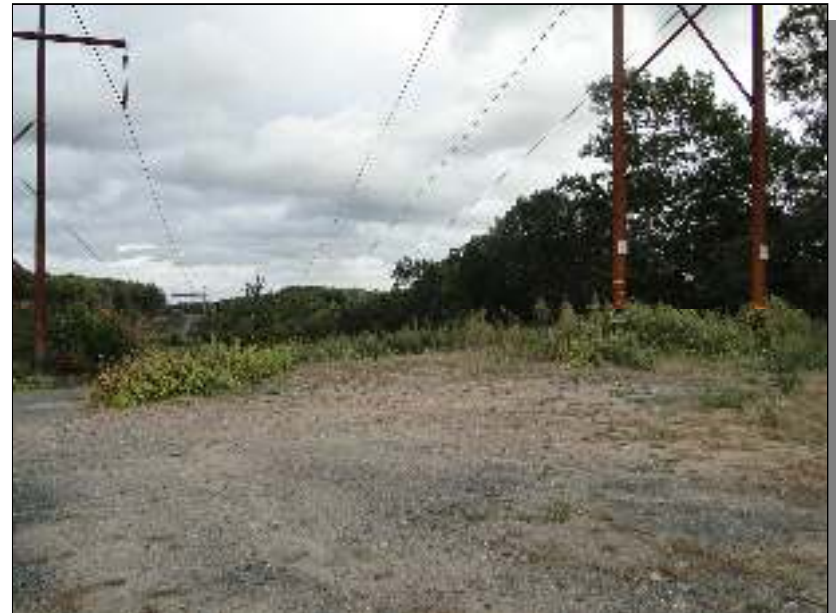
Photo 24: Part of Pad # 3 received fertile topsoil & sprouted mugwort & other tall weeds, like toxic Jimson weed. Rest is bare & poorly permeable.

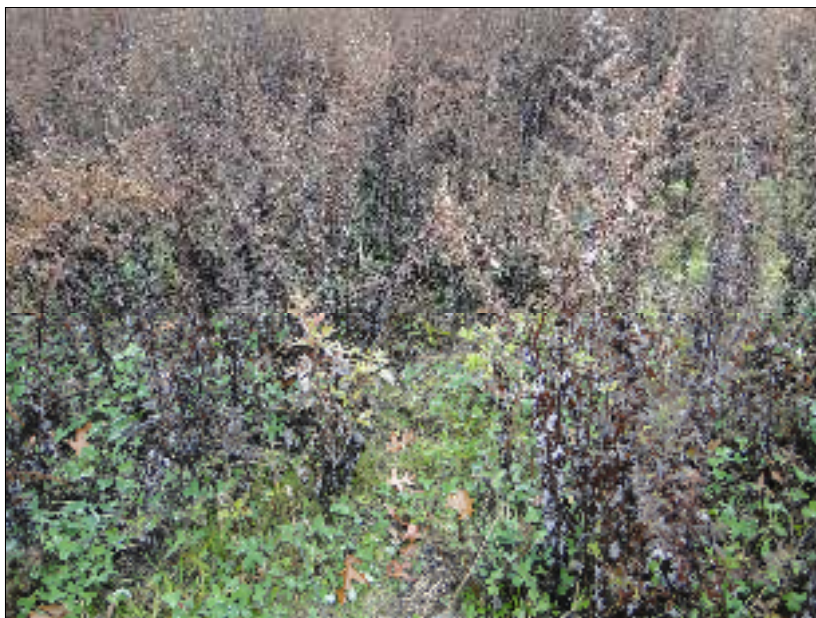
Photo 25: On Pad # 1 thick impervious stone process fill was covered with 2-4" of fertile, garden-type topsoil that contained mugwort seeds. It was seeded with clover & grasses, soon overtopped by mugwort.

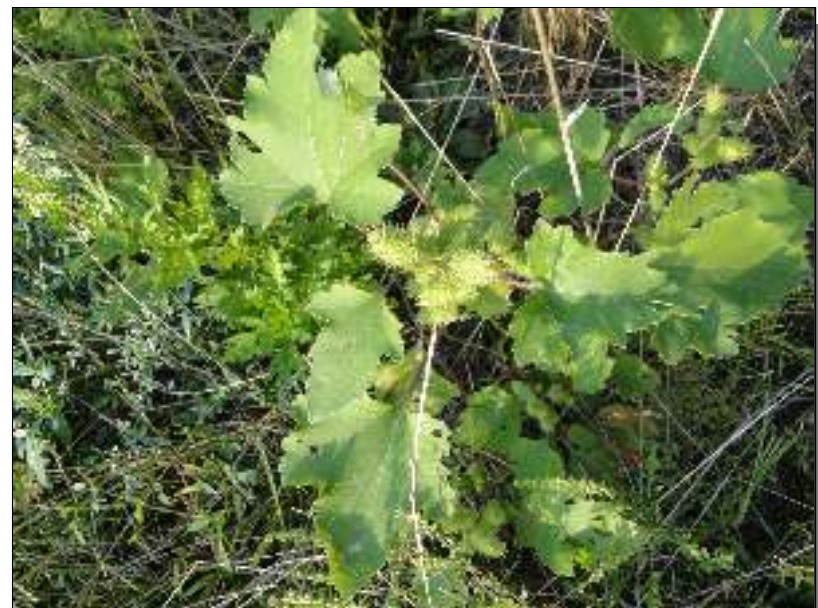
Photo 26: ~ 200 sf of the poisonous Jimson weed were cut down from Pad #3 and a part of Pad #4, before seeds were ripe, & bagged by Mr. Therrien. However, seed from mugwort on Pad #1 washed down the hill.

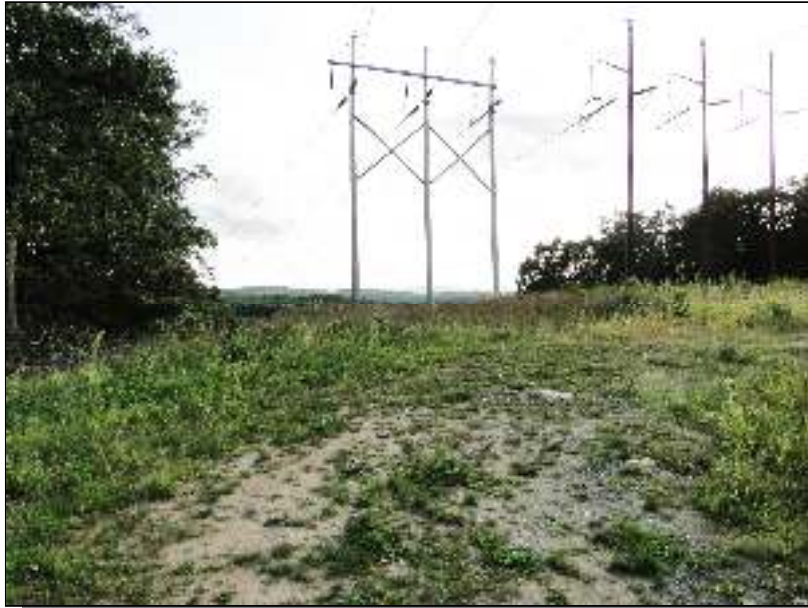
Photo 27: Most of the native shrub & grassland cover has been lost, & over 2 acres of dense fill was added for service roadways & work pads.

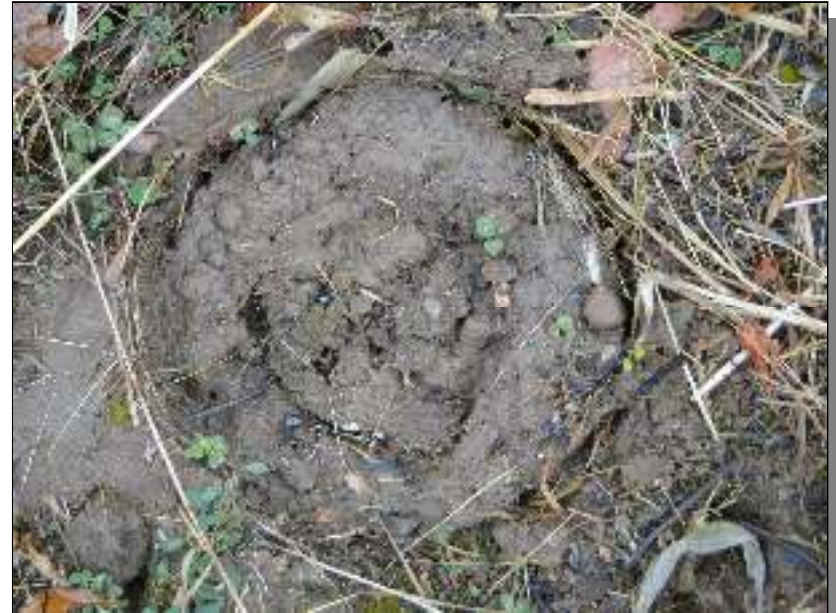
Photo 28: A double ring infiltrometer confirmed on 11-11-19 that the substrate on Work Pad #3 is much less pervious than natural hilltop soil.

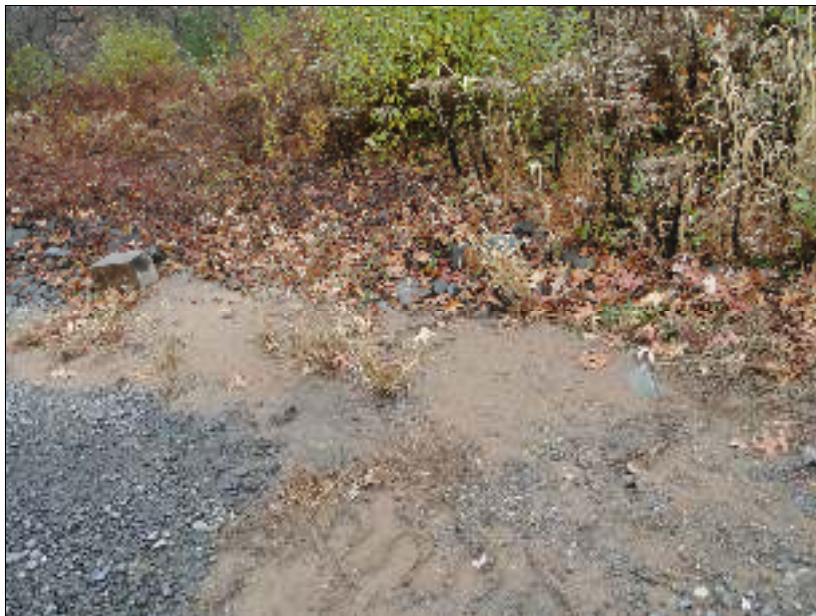
Photo 29: Observations during a minor rain event on 11-12-19, showed that runoff begins early in the event, & dislodges nutrient-laded fine soils, washing them northerly down the hill. This will alter naturally infertile soils.

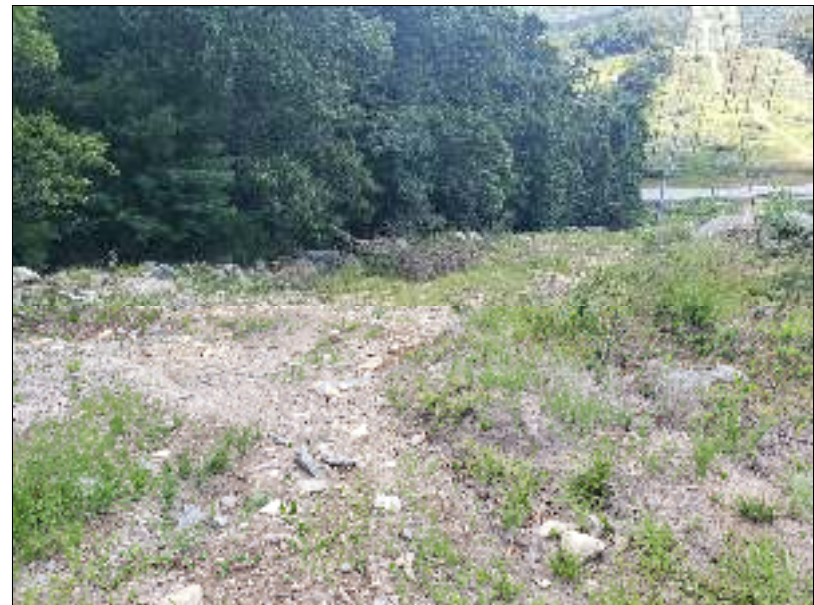
Photo 30: Runoff has already caused substantial erosion on the steep southwestern hill below the new pads on the hilltop. It was worsened by cutting multiple red cedars that had been anchoring the hillside soil.

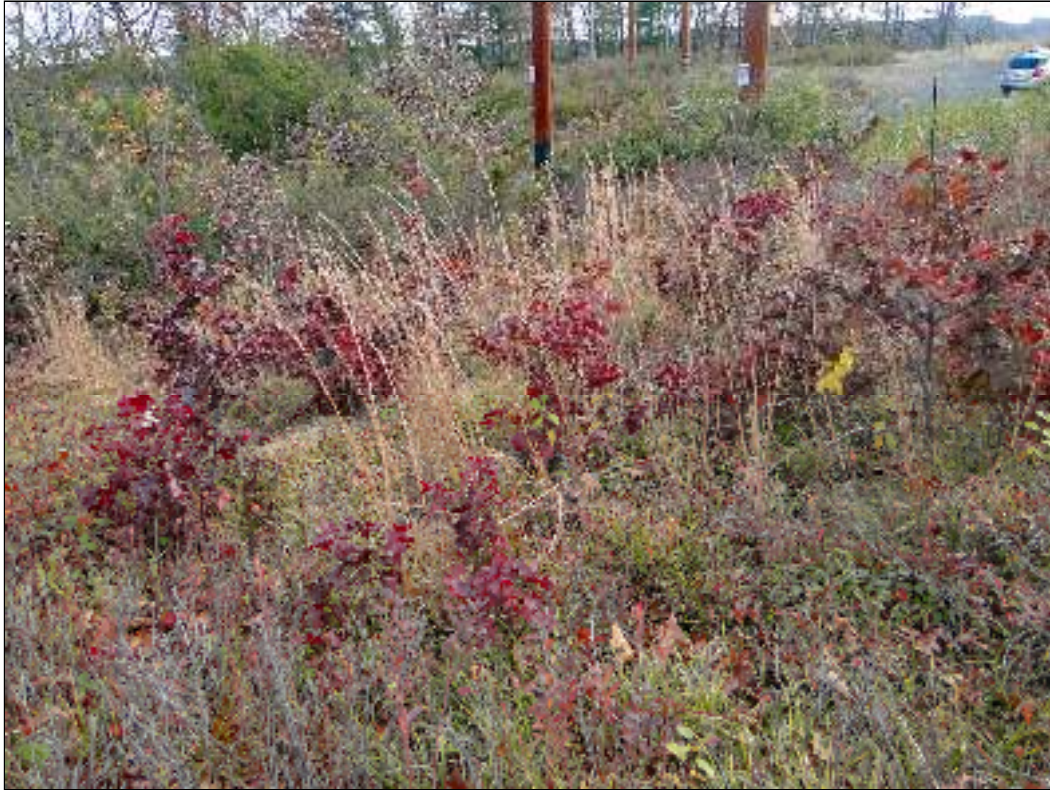
Photo 31: Southerly view. Much natural vegetation remains around Work Pad # 4. Timber matting was used over a small area, instead of placing impervious fill. 11-8-19.

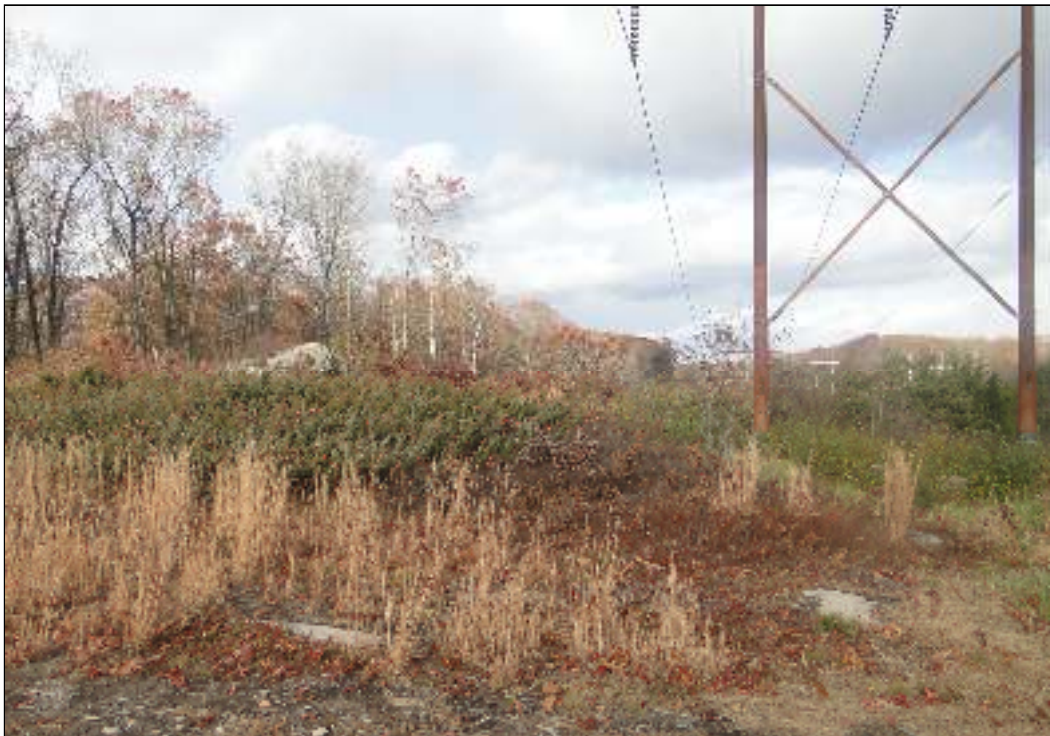
Photo 32: Northwestern view of Pad #4. Heavy equipment clearly operated from this side. Permeability was good, averaging 0.56 minutes for each 1" drop in water level.
